# Manhole Inspection Summary

Manhole # S35S\_\_066MH

Insp Date: 1/30/08 12:39 PM

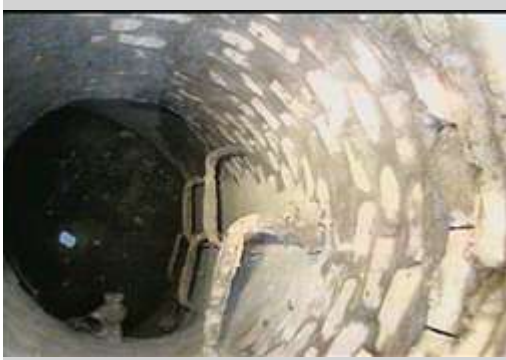
Defect 2

Condition: ☐ Sound ☐ Cracked ☐ Root Intrusion ☒ **Loose Brick** ☐ Deteriorated

Count: **5** Missing: **0** ☒ **Corroded**

corbel condition loose bricks, corroded steps

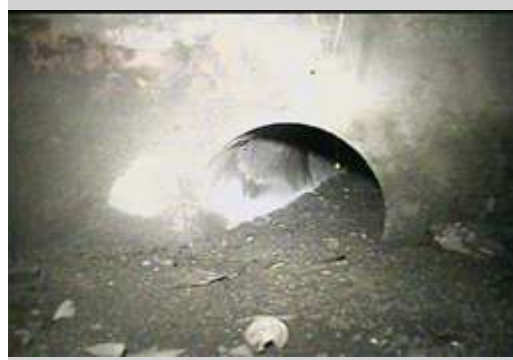
Defect 1

Condition: ☐ Sound ☐ Cracked ☐ Root Intrusion ☐ Deteriorated ☐ Leaks ☒ **Debris**

Channel Debris

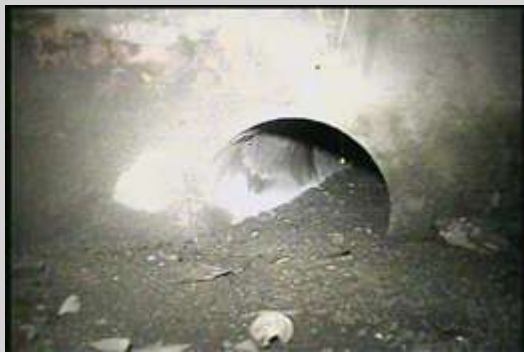
12 O'Clock Outflow

8 in. Circular Gravity Sewer  
Pipe Out @ 12 O'Clock

Deposits: ☐ None ☐ Mud ☒ **Sludge** ☐ Debris ☐ Grease

Silt Depth: **4** (in.) Deposits Extent: **Medium**
